In This Issue

Volume 25, Issue No 3

Welcome to the third IDEST Torque of 2025. Perhaps this edition should be subtitled valves special as we seem to have lots of articles on that subject. We also answer lots of very tricky questions from the field. Hopefully something for everyone, read on to find out.

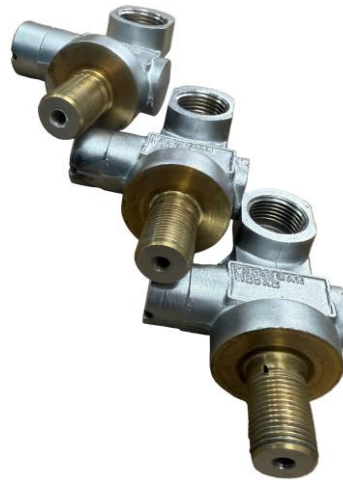
One of our centres reported receiving multiple cylinders for PIAT which turned out to be fitted with M25 valves that had been machined down to M18 thread.

The cylinders were well passed their periodic test interval, so this machining operation was carried out some years ago.

Used in a non-diving application, the owner reported having purchased the valves online.

Modification of valves and threads in this way, without manufacturer authorisation and safety recertification of the valve, is potentially very risky. The centre acted correctly by informing the owner who agreed to the replacement of the valves with proper M18 alternatives.

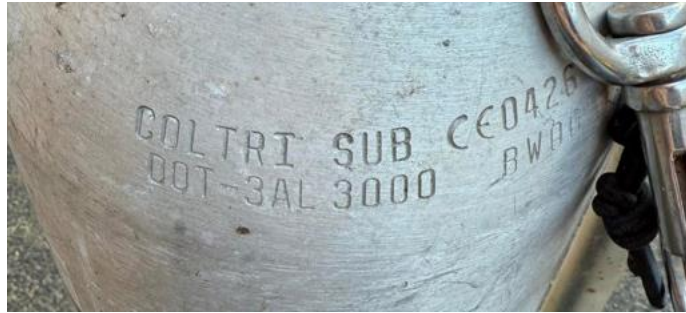
The cylinder neck stamping reads as follows:

COLTRI SUB CE0426 PS200BAR TS-20/+60C PT344BAR 14.2KG DIVING BREATHING GAS
DOT-3AL 3000 BW0003141 M4002 02@11 CATALINA S80 M25X2

What captured our interest was the CE0426 stamp. This is a European notified body marking belonging to ITALCERT SRL [\[link\]](#).

So, it appears to us to be a case of dual marking, and this cylinder can be tested, filled and used within the UK.

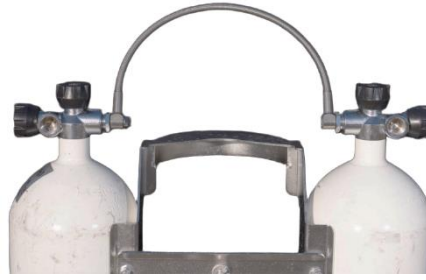
The cylinder valves on this rebreather configuration employ a novel multiple outlet system with a flexible high pressure manifold linkage.

The challenge was that the CE EN144-1 M25x2 LOLA valves are marked as rated to 200 bar, and the 7-liter Eurocylinder Systems AG (ECS) cylinders are marked as working pressure 230 bar.

A clear pressure mismatch exists between the valve and the cylinder. The HSE's no nonsense approach is to adopt sound engineering practice. If the cylinders are pumped to 230 bar then that exceeds the typical 10% over pressure allowance of the valve (especially if you consider heat of compression). 230 bar valves are commonly available so the simplistic answer could have been to say reject the combination. However, alternative 230 rated valves that support this flexible high pressure manifold arrangement are not widely available so, adopting a pragmatic approach we gave the following guidance...

Complete the PIAT in full, remediating any issues found. Apply the red pressure mismatch quadrant label to each cylinder. Document in writing on both the worksheet and test certificate that **the maximum working pressure of the 'system' is 200 bar and this should not be exceeded.**

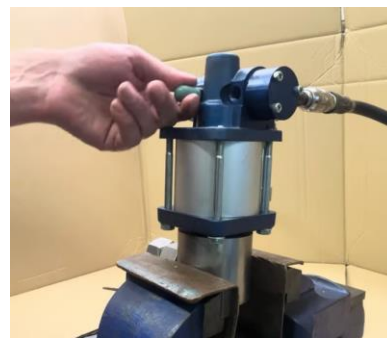
HPS description *"In this video we will show you what to expect when the silencers become blocked on a Trojan pump. Due to contamination from the air and surrounding atmosphere over time the silencers can become blocked which will slow down the operation of your pump. You can see in this video it is safe to remove the silencers to confirm that they are causing the issue."*
