IDEST Torque

Newsletter December 2025

Volume 25, Number 4

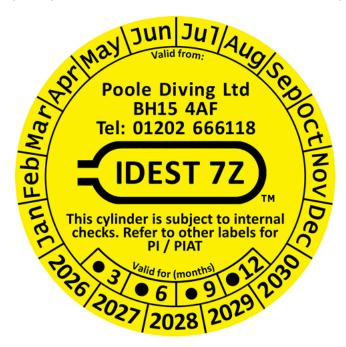
The inspiration for these labels has come following requests for a uniform standard labelling method to indicate a visual inspection more frequently that the usual 30-month PI. Here's a sample label:

Diving cylinders in some countries must be visually inspected annually or are subject to the "High Risk of water ingress" status through regular emptying of content underwater with some commercial operations.

They also support emergency raft or BA sets where inspections through a company protocol or insurance requirement also require more frequency.

IDEST has launched a new Additional Visual Inspection (AVI) label on our web store.
