## In This Issue

## Volume 24, Issue No 1

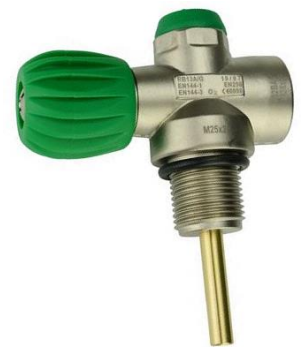
A short note regarding the AP Diving Progressive-Opening Oxygen Cylinder Valve, of relevance to both cylinder test technicians and filling station operators.

AP Diving advise *"As of October 2019 all AP Oxygen Rebreather Valves are fitted with a needle-valve seat which offers progressive-opening of the valve. When pressurising the oxygen system, for the first half turn or so it appears that nothing is happening. You should continue to open the valve a fraction at a time until the HP gauge needle just starts to move, if necessary, closing the valve slightly if the pressurisation rate is too fast, then stop and wait until it reaches full pressurisation."*

From a service perspective it is important to note that the original AP Cylinder Valve (both oxygen and diluent) use a different service kit from the new Progressive-Opening Oxygen Cylinder Valve.

- RB13E - Rebreather Cylinder Pillar Valve Service Kit (M25 thread), with new Oxygen AP38C Needle valve
- RB13D - Rebreather Cylinder Pillar Valve Service Kit (M25 thread), with original oxygen and diluent AP38 Moulded Insert

Based on this comment on an internet forum, mistakes have been made... *"One thing to watch with the AP slow turn on O2 valves: if when testing and servicing your cylinders the highly trained IDEST technician decides to fit a generic service kit to the valve rather than the correct AP parts the valve will snap to fully open with a fraction of a turn. Not quite what was intended."*

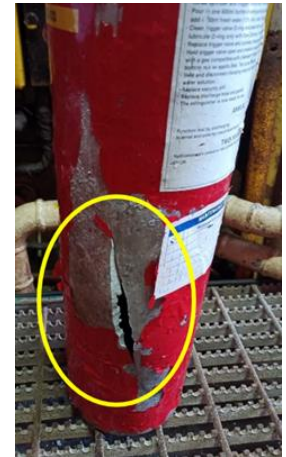
While fire extinguishers are not within our scope we were interested to see a recent 'Safety Flash' by the International Marine Contractors Association (IMCA) regarding the failure of a 5kg CO<sub>2</sub> fire extinguisher during hydrostatic pressure testing.

The extinguisher, rated to 200bar, was being tested to a pressure of 300bar. The incident occurred when the test pressure reached 196 bar and the main body of the extinguisher failed. The extinguisher was 13 years old. As the failure occurred under test conditions no personnel were nearby to get injured.

The failure serves as a reminder of the importance of regular inspection, maintenance, and age considerations when dealing with critical safety equipment.

- Reviewed the current inspection and maintenance program to ensure it is implemented correctly and is rigorous enough for inspection and maintenance of fire extinguishers;
- Considered the age of fire extinguishers when planning hydrostatic tests. Older extinguishers may require more frequent testing or replacement to ensure their safety and reliability;
- Ensured detailed records of inspections, maintenance, and hydrostatic testing are kept for all fire extinguishers. These records can provide valuable insights into the condition of your equipment over time;
- Ensured that personnel involved in handling and testing fire extinguishers are adequately trained and aware of the potential risks associated with aged or damaged equipment.
